EUROPEAN PATENT APPLICATION

21 Application number: 80303100.4

54 A fluid transport hose.

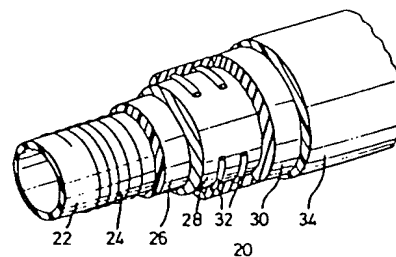
FIG.2.

Figure 2 shows a section of a hose forming part of the pipeline shown in Figure 1, the hose section being cut away to illustrate the composite structure of the hose.

Referring to Figure 1, there is shown a tanker 10 moored by a buoy 12. Oil is transferred from the tanker 10 to the buoy 12 through an oil transfer pipe 14 which is flexible and which may float in part. The oil is delivered to an onshore station via the submerged pipeline 16. The transfer pipe 14 is formed of individual hose sections 20 which are flanged at each end so that they may be joined together. The hose sections 20 must be flexible and yet capable of withstanding the harsh environment to which they are subjected. The hose sections 20 are of a composite structure and this is illustrated in Figure 2. Each hose section 20 consists of a high grade synthetic rubber tube 22, a sensing element 24 which is in contact with the outer surface of the tube 22, a textile ply 26 impregnated and coated with synthetic rubber, an overlay 28 of plies of braided high tensile steel cable, a layer of synthetic rubber 30 in which helically wound steel wire 32 is embedded and an outer sheath of wear resistant material 34.

57 The present invention relates to fluid transport hoses (20) suitable for transporting oil from a tanker to a mooring buoy at sea.

In order to detect the imminent rupture of a hose (20) there is provided a sensing element (24) located between the plies (22,26), the sensing element (24) being responsive to the electromagnetic properties of the fluid present between the plies (22,26) as a result of a failure of an inner ply (22) of the hose (20). Alternatively, the sensing element (24) may be adapted to respond by presenting an open circuit upon failure of the inner ply (22) of the hose (20). A fibre optic element may be advantageously employed as the sensing element (24) in this alternative. The sensing element (24) may respond by a change in the conductance, capacitance and/or inductance or in its ability to carry a radio frequency signal.

5 The sensing element 24 is comprised of a coil of fine wire wrapped around the tube 22 and connected to a sensing unit (not shown) which is responsive to a change in the electrical impedance of the coil. This embodiment of the sensing element 24 is particularly useful since it is responsive to the presence of oil between the plies and is also responsive to the deformation of the tube 22. In the event of oil seepage, the inductance of the coil 24 will be changed by virtue of the change in the magnetic properties of the material immediately contacting the coil 24 and in the event of deformation of the tube 22 this will change the inductance of the coil 24 but may additionally cause rupture of the coil 24 resulting in an open circuit. The coil 24 is positioned adjacent the tube 22 in order to provide an early indication that breakdown of the hose section 20 is imminent.
